### COMPRESSIVE STRENGTH OF DAMAGED AND REPAIRED COMPOSITE PLATES

Scott R. Finn and George S. Springer  
Department of Aeronautics and Astronautics  
Stanford University, Stanford, California

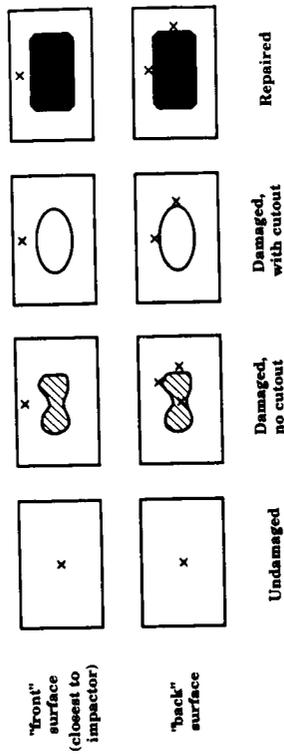
x - Strain gauge locations  
 Figure 3. Locations of the strain gauges.

After holes were cut in the plates, the plates were repaired by placing a "plug" (made of the same material as the plate) in the hole (Figure 1). This plug had the same shape and size as the hole, and had the same layup as the plate. American Cyanamid FM300 adhesive was placed between the plug and the plate. One layer of Fiberite T300/976 graphite-epoxy cloth "patch" was placed above the plug on each side of the plate. The dimensions of the patch are given in Figure 2. The plates were vacuum bagged and cured. Strain gauges were then mounted on the plates (Figure 3).

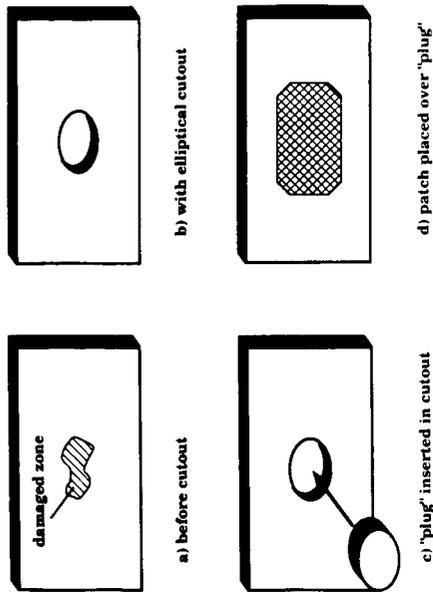
Figure 1. Description of the plate a) before cutout, b) with cutout, c) with plug inserted in cutout, and d) with patch placed over plug.

The damaged zone was removed by grinding out an elliptical hole through the entire thickness of the plate (Figure 1). After grinding, the plate was again X-rayed to establish that the process did not damage the plate further.

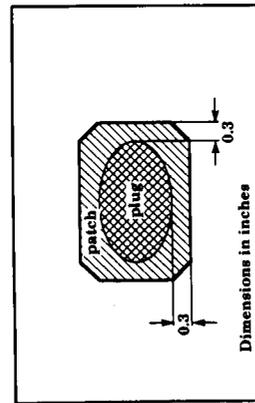
Figure 2. Dimensions of the patch used in repairing the plate.

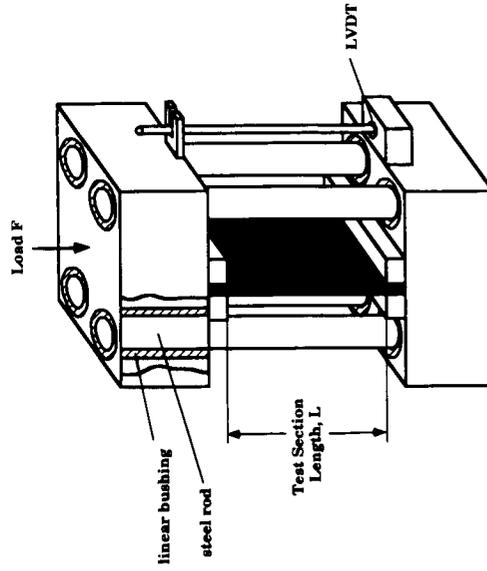
Figure 4. Compression test fixture.

The compressive strength of each plate was measured by clamping the two short edges of the plate in a specially built fixture (Figure 4). The compressive load was applied at a displacement rate of  $2 \times 10^{-5}$  in/sec, and the load versus strains and the load versus displacement were measured.

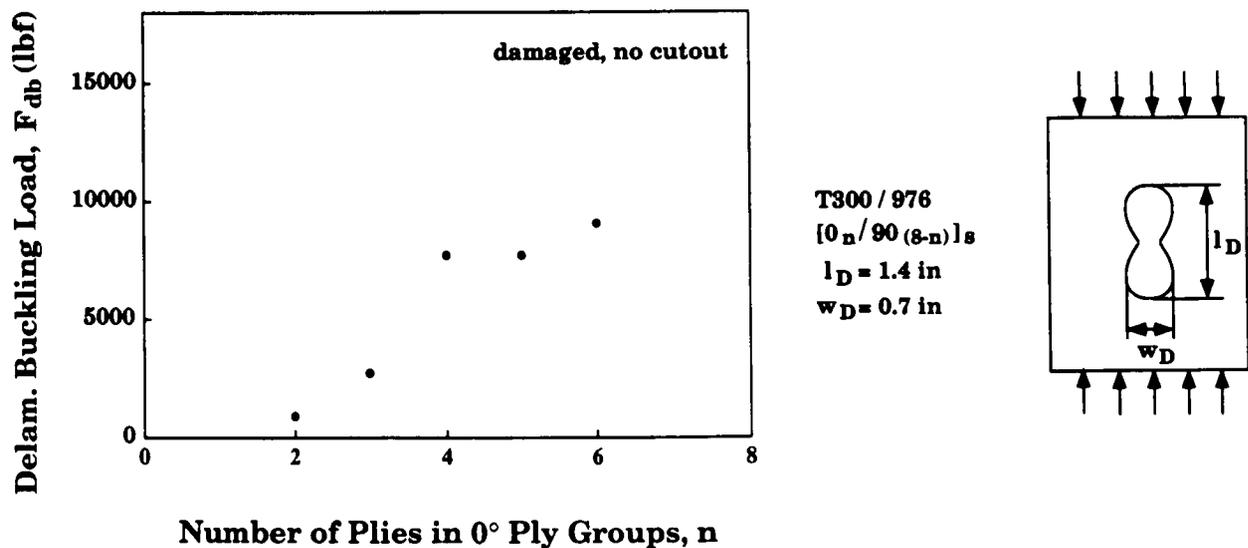
Figure 5. Delamination buckling load  $F_{db}$  as a function of the number of plies  $n$  in the  $0^\circ$  ply groups. Test section length  $L = 3$  in.

The load (delamination buckling load  $F_{db}$ ) at which a sublaminate in the damaged zone buckles increased as the number  $n$  of plies in the  $0^\circ$  ply groups increased, i.e., as the thickness of the back ply group increased (Figure 5). This can be explained by observing that when the load was applied, the sublaminate below the damaged zone (at the "back" side of the plate) buckled. A thicker back ply group corresponds to a sublaminate which is stiffer and thus more resistant to buckling.

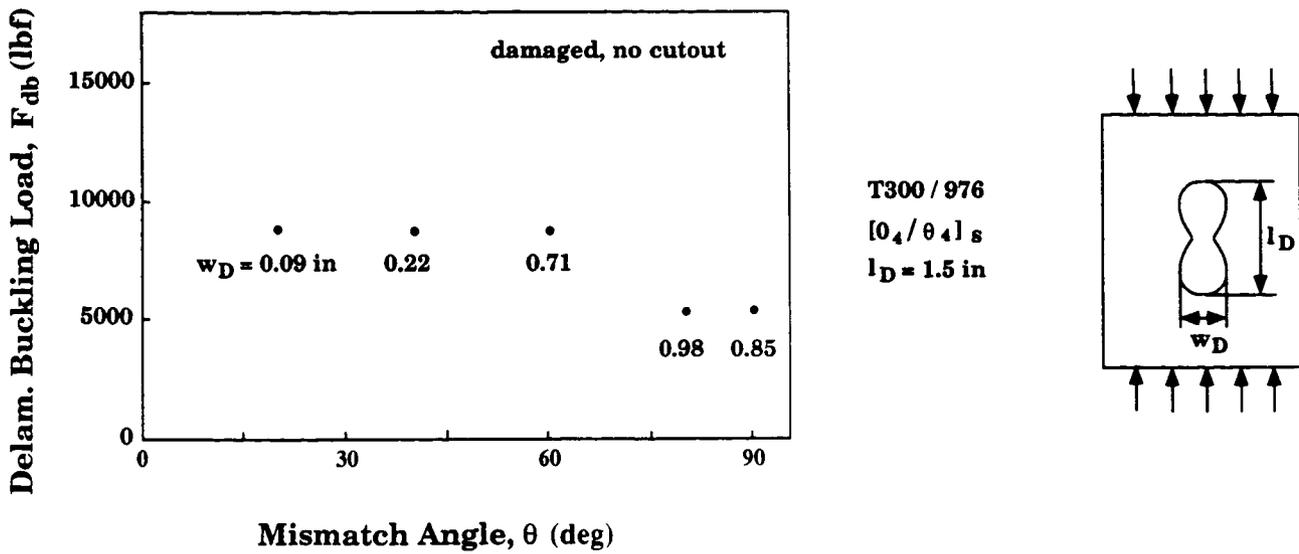
Figure 6. Delamination buckling load  $F_{db}$  as a function of the mismatch angle  $\theta$ . Test section length  $L = 3$  in.

The delamination buckling load  $F_{db}$  decreased with mismatch angle  $q$  (Figure 6). To explain the reason for this, we observe that the data shown in this figure apply to plates in which the damage length was constant ( $l_D = 1.5$  in), while the width was not controlled independently. In fact, the damage width  $w_D$  (and consequently the damaged area) increased with the mismatch angle  $q$  (Figure 6). Thus the size of the damaged area increased resulting in a decrease in the delamination buckling load  $F_{db}$  with increasing mismatch angle  $q$ .

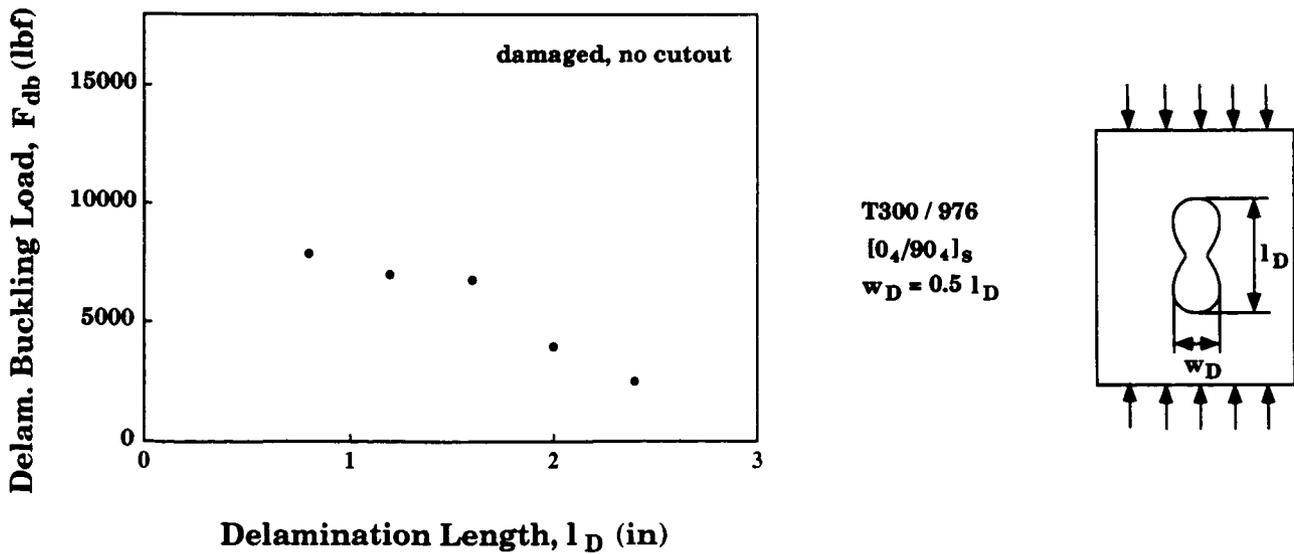
Figure 7. Delamination buckling load  $F_{db}$  as a function of the initial damaged zone length  $l_D$ . Test section length  $L = 3$  in.

The delamination buckling load  $F_{db}$  as a function of the initial damaged zone length  $l_D$  is shown in Figure 7. For these  $[0_4/90_4]_S$  plates, the width  $w_D$  of the damaged zone was approximately equal to one half of the damage length  $l_D$ . As the length  $l_D$  increased (and with it, the size of the damaged zone), the load required to buckle the sublaminate decreased.

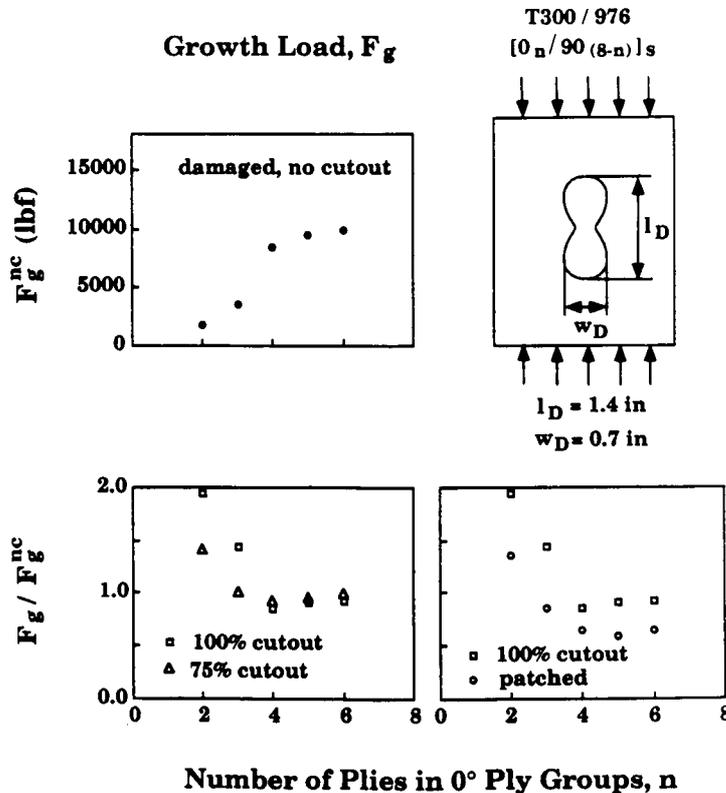
Figure 8. Damage growth load  $F_g$  as a function of the number of plies  $n$  in the  $0^\circ$  ply groups. Test section length  $L = 3$  in.

The damage growth load  $F_g$  as a function of the number of plies  $n$  in the  $0^\circ$  ply groups is shown in Figure 8. For damaged plates with no cutout, the growth load increased with the number of plies in the  $0^\circ$  ply groups. To explain this trend it is again noted that the buckled sublaminates were at the back of the plate. Accordingly, an increase in the number of plies  $n$  in the back  $0^\circ$  ply group corresponded to an increase in the stiffness of the sublaminates and an increase in the delamination buckling load  $F_{DB}$  (Figure 5). For the plates with no cutout or repair, damage growth was always preceded by delamination buckling. Therefore, the damage growth load  $F_g^{nc}$  also increased with increasing number of plies  $n$  in the  $0^\circ$  ply groups.

Cutting out the damage resulted in an increase in the damage growth loads  $F_g$  provided the back ply groups were relatively "thin" ( $n=2,3$ ). The reason for this is that removal of the damaged zone prevented delamination buckling and delayed damage growth. Furthermore, plates with 100% cutout had higher growth loads than those with 75% cutout because, in the latter case, not all the damaged zone was removed. Cutting out the damaged zone did not affect the damage growth loads  $F_g$  of plates with "thick" back ply groups ( $n=4-6$ ). Because of the large back ply group thickness (corresponding to high stiffness of the sublaminates), in these plates, the damage started to grow even before the sublaminates buckled.

Repaired plates had lower damage growth loads than plates with 100% cutouts (Figure 8, right). The reason for this is unclear, but it is likely that damage could initiate at the interface between the plate and the plug.

Damaged plates, of course, had lower ultimate loads than undamaged plates. Cutting out some or all of the damaged zone further reduced the ultimate loads. It is interesting to note that while, in general, cutting out the damaged zone increased the damage growth loads  $F_g$  (Figure 8), it reduced the ultimate loads. Thus, cutting out the damaged zone may not always be advantageous.

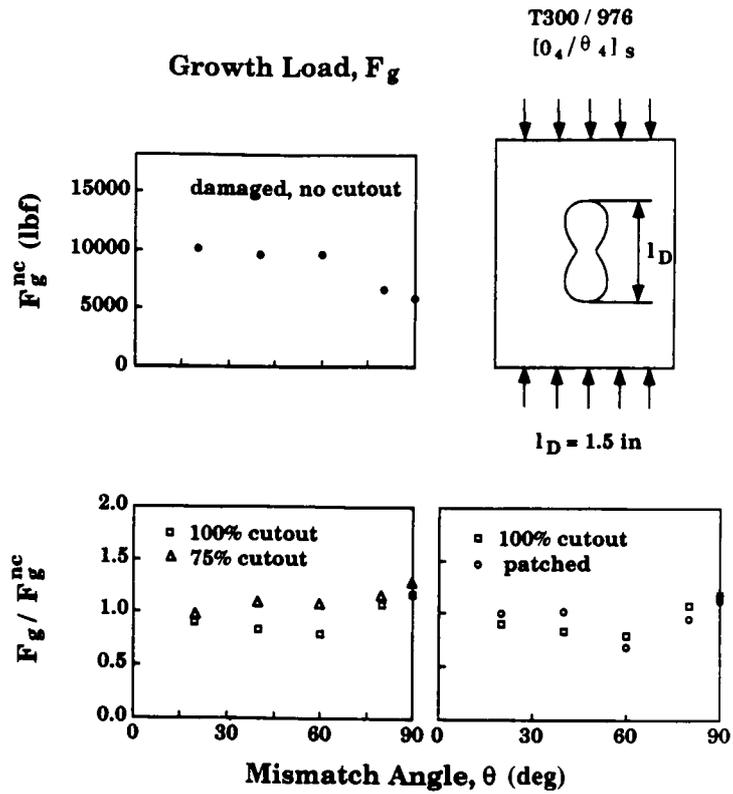
Figure 9. Damage growth load  $F_g$  as a function of the mismatch angle  $\theta$ . Test section length  $L = 3$  in.

The damage growth load  $F_g$  as a function of the mismatch angle  $q$  is shown in Figure 9. For damaged plates with no cutout, the growth load decreased as the mismatch angle increased (Figure 9, top). The reason for this decrease was that larger mismatch angles were accompanied by larger initial damaged zones (as was discussed in Section 3.1) and lower delamination buckling loads  $F_{db}$  (Figure 6). Since the size of the damaged zone increased with increasing mismatch angle  $q$ , the growth load  $F_g^{nc}$  decreased. Neither removing the damaged zone nor repairing it had a significant effect on the damage growth loads, as shown in Figure 9, bottom.

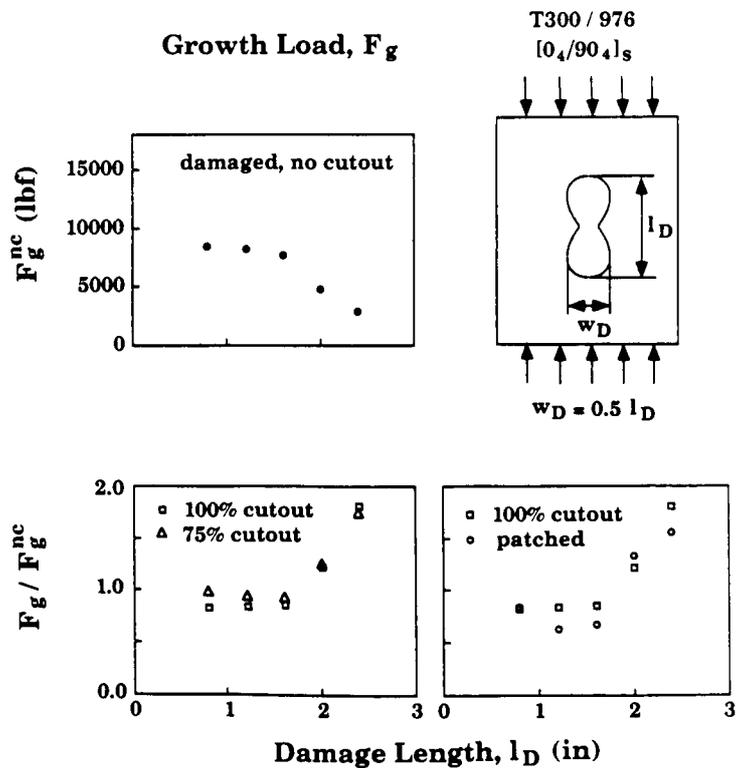
Figure 10. Damage growth load  $F_g$  as a function of the initial damaged zone length  $l_D$ . Test section length  $L = 3$  in.

The damage growth load  $F_g$  as a function of the initial damaged zone length  $l_D$  is shown in Figure 10. For plates with no cutout or repair, the damage growth load  $F_g^{nc}$  decreased with the damage length  $l_D$ . Since the damage width  $w_D$  increased along with the damage length, the overall size of the damaged zone increased. This increase in the size of the damaged zone resulted in the decrease in growth load  $F_g^{nc}$ .

For plates with relatively "small" initial damage lengths ( $l_D < 2$  in), the damage started to grow before the sublaminates buckled. Hence, in this case, cutting out the damaged zone did not change significantly the damage growth load, i.e. the damage growth loads for plates with and without cutouts were nearly the same (Figure 10, middle). For plates with larger initial damage lengths ( $l_D \geq 2$  in), the sublaminates buckled, and this event governed the damage growth. In this case, cutting out the damaged zone resulted in an increase in the damage growth loads  $F_g$ . Repairing the plates seemed to produce little or no change in the growth load compared with plates with 100% cutout (Figure 10, right).

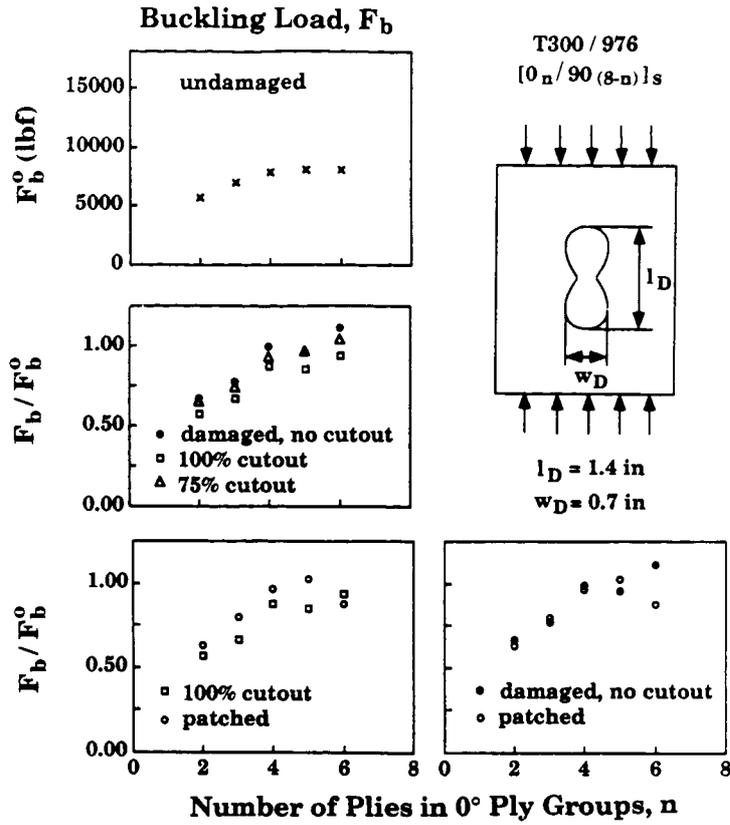
Figure 11. Buckling load  $F_b$  as a function of the number of plies  $n$  in the 0° ply groups. Test section length  $L = 3$  in.

The global buckling load  $F_b$  as a function of the number of plies  $n$  in the  $0^\circ$  ply groups is shown in Figure 11. For initially undamaged plates, the buckling load  $F_b^0$  increased slightly as  $n$  (and hence the number of  $0^\circ$  plies in the plate) increased. As the number of  $0^\circ$  plies in the plate increased, so did the bending stiffness of the plate in the lengthwise direction. This resulted in an increase in the buckling load  $F_b^0$ .

As expected, damaged plates, with or without cutout, generally had lower buckling loads  $F_b$  than undamaged plates. The removal of all or part of the damaged zone generally produced a small decrease in the buckling load compared to the buckling load of damaged plates with no cutout. Although the material in the damaged zone was not as strong as the undamaged material, it still provided some resistance to buckling. For this reason, removal of the damaged material caused a decrease in the buckling loads  $F_b$ .

Repaired plates had slightly higher buckling loads than plates with 100% cutout. However, repaired plates had practically the same buckling loads as damaged plates with no cutout. Inserting new material into the damaged zone provided more buckling resistance than a cutout, but not more than the original damaged material.

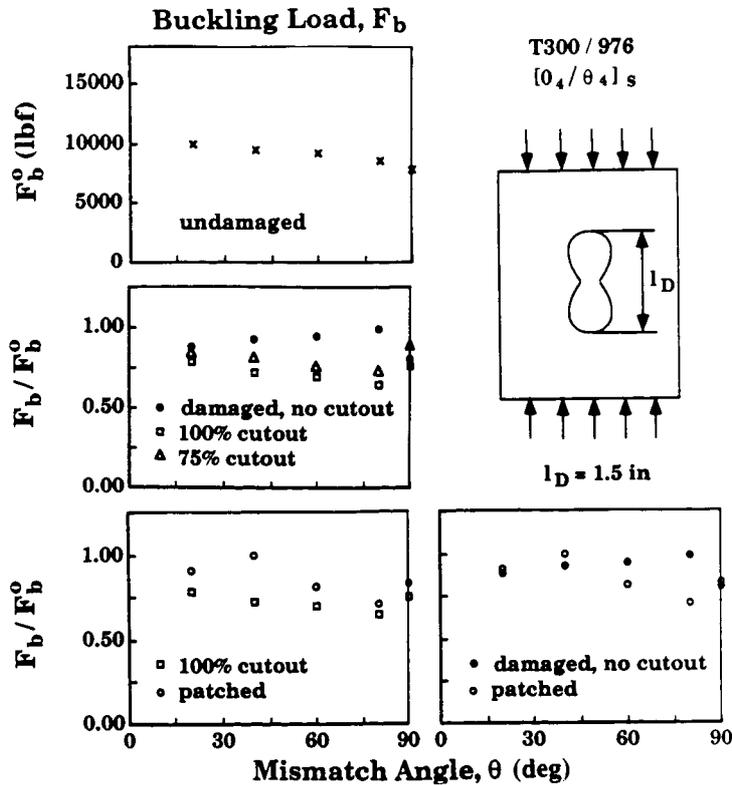
Figure 12. Buckling load  $F_b$  as a function of the mismatch angle  $\theta$ . Test section length  $L = 3$  in.

The global buckling load as a function of the mismatch angle  $q$  is shown in Figure 12. For initially undamaged plates, the buckling load  $F_b^0$  exhibited a slight decrease with mismatch angle (Figure 12, top). As the angle  $q$  increased, the stiffness of the laminate in the lengthwise direction decreased leading to the decrease in the buckling load.

Damaged plates with no cutout had lower buckling loads than undamaged plates ( $F_b/F_b^0 < 1$ ), but higher buckling loads than plates with the damaged zone removed. Removal of the material, even though it was damaged, resulted in less resistance to plate buckling. Repaired plates had higher buckling loads  $F_b$  than plates with a 100% cutout, but only about the same buckling loads as damaged plates with no cutout.

The ultimate load  $F_u$  is shown in Figure 15 as a function of the mismatch angle  $q$ . For undamaged plates, the ultimate load  $F_u^0$  decreased with the mismatch angle. Again, there are two reasons for this decrease. First, the buckling load  $F_b^0$  decreased with mismatch angle (Figure 12). Lower buckling loads lead to a decrease in the ultimate load. Second, increasing the angle  $q$  in the  $[0_4/q_4]_S$  plates moved the fiber direction of the middle ply group farther out of alignment with respect to the applied axial load  $F$ . This resulted in higher longitudinal stresses for a given applied load, and hence to a decrease in the ultimate load  $F_u$  with increasing mismatch angle  $q$ .

Damaged plates had lower ultimate loads  $F_u$  than corresponding undamaged plates. Cutting out some or all of the damaged zone further reduced the ultimate loads, because cutouts decreased the buckling loads of the plates (Figure 12). Repair of the plates did not change significantly the ultimate loads  $F_u$ .

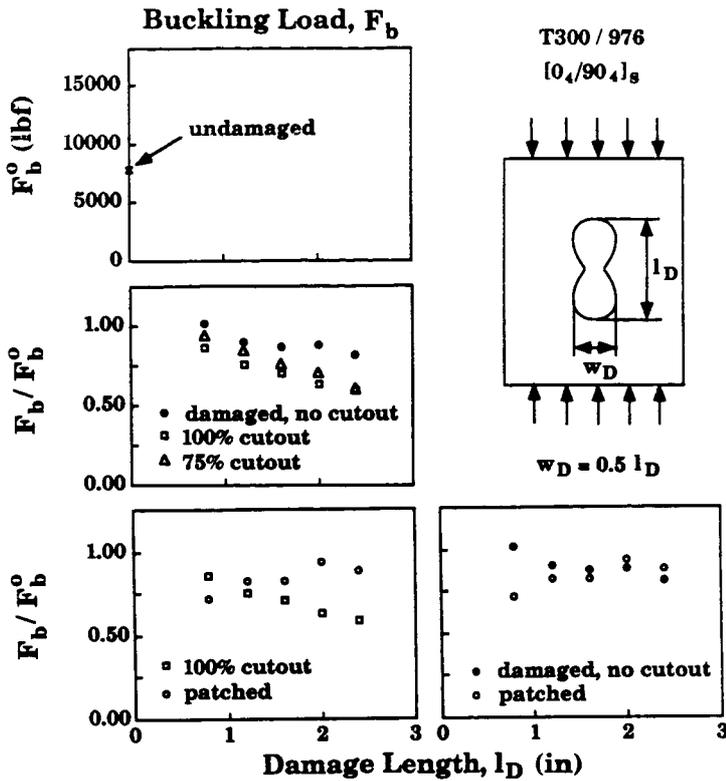
Figure 13. Buckling load  $F_b$  as a function of the initial damaged zone length  $l_D$  for T300/976 graphite/epoxy. Test section length  $L = 3$  in.

For damaged plates with and without cutouts, the buckling load  $F_b$  decreased as the initial damaged zone length  $l_D$  increased (Figure 13). Since the damage width  $w_D$  increased with the damage length  $l_D$ , the size of the damaged zone also increased. This increase in the size of the damaged zone caused a decrease in the global buckling load  $F_b$ . Again, damaged plates without a cutout generally had higher buckling loads than the plates with either 100% or 75% cutouts.

Repaired plates had higher buckling loads than plates with 100% cutout but only about the same buckling loads as damaged plates with no cutout.

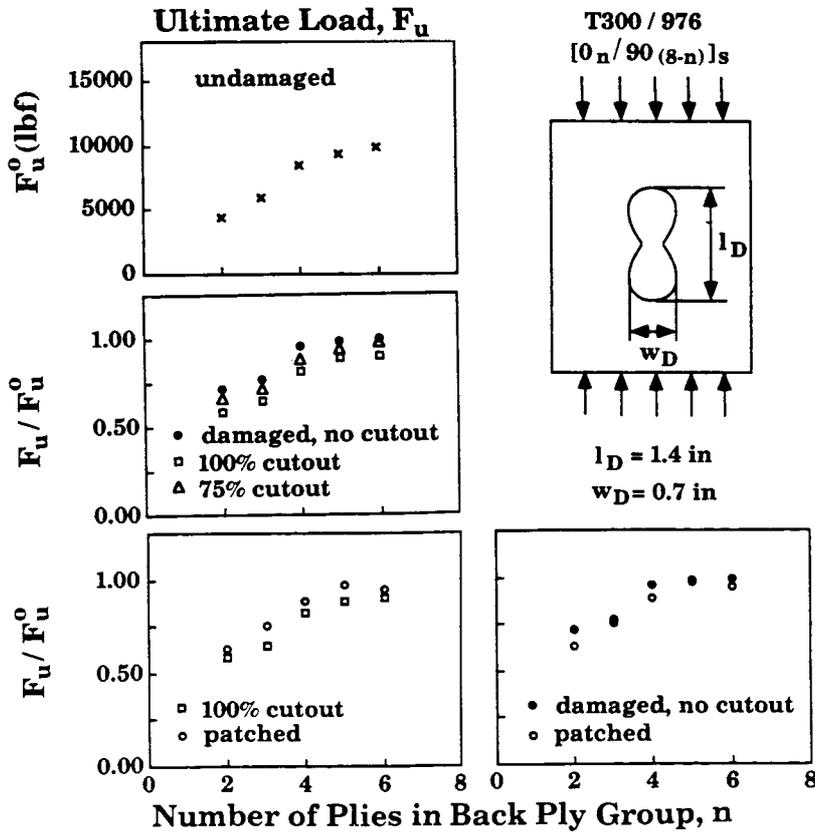
Figure 14. Ultimate load  $F_u$  as a function of the number of plies  $n$  in the  $0^\circ$  ply groups. Test section length  $L = 3$  in.

The ultimate load  $F_u$  as a function of the number of plies  $n$  in the  $0^\circ$  ply groups is shown in Figure 14. For initially undamaged plates, the ultimate load  $F_u^0$  increased as  $n$  (and correspondingly, the number of  $0^\circ$  plies in the plate) increased. There are two reasons for this trend. First, the plate buckling load  $F_b$  increased with  $n$  (Figure 11), and higher buckling loads generally cause higher ultimate loads. Second, for a load applied in the lengthwise direction, a higher number of  $0^\circ$  plies in the plates corresponds to a lower longitudinal stress in each ply. Since the ply stresses decreased with the number  $n$  of plies in the  $0^\circ$  ply groups, the ultimate load  $F_u^0$  increased.

Repaired plates had higher ultimate loads  $F_u$  than plates with 100% cutout, but about the same ultimate loads as damaged plates with no cutout. Hence, repair does not seem to enhance the ultimate load.

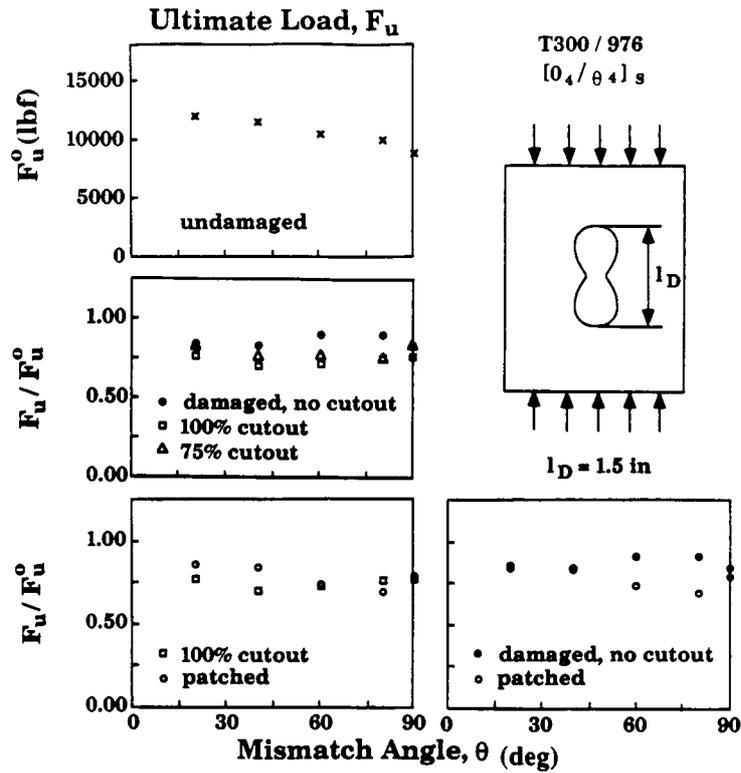
Figure 15. Ultimate load  $F_u$  as a function of the mismatch angle  $\theta$ . Test section length  $L = 3$  in.

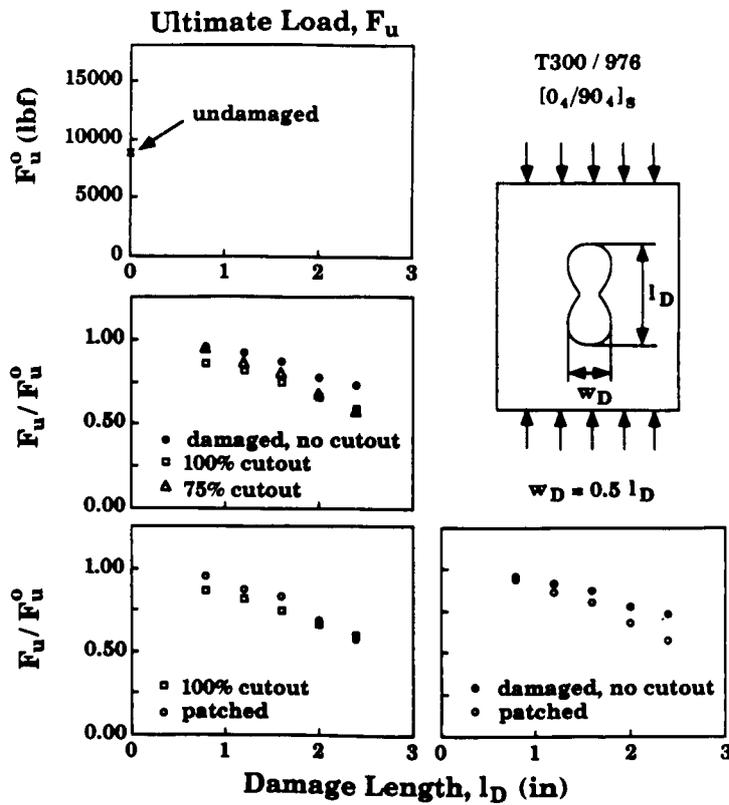
Figure 16. Ultimate load  $F_u$  as a function of the initial damaged zone length  $l_D$  for T300/976 graphite/epoxy. Test section length  $L = 3$  in.

For damaged plates with no cutout, the ultimate load  $F_u$  decreased as the initial damaged zone length  $l_D$  increased for all three materials (Figure 16). Since the damage width  $w_D$  increased with the damage length  $l_D$ , the overall size of the damaged zone also increased. The increase in the size of the

damaged zone caused a decrease in the ultimate load  $F_u$ . For all three materials, the removal of part or all of the damaged zone resulted in the plates having lower ultimate loads  $F_u$  than damaged plates with no cutout.

Repaired plates had slightly higher ultimate loads  $F_u$  than plates with 100% cutout. However, repaired plates had lower ultimate loads than damaged plates with no cutout.
